Hapua Thrive – Margot Nicholson

Vision: 'a healthy valley and foreshore appreciated and nurtured by the community

Community concerns "STINK" Water Quality www.hapuathrive.nz^{Reserve}

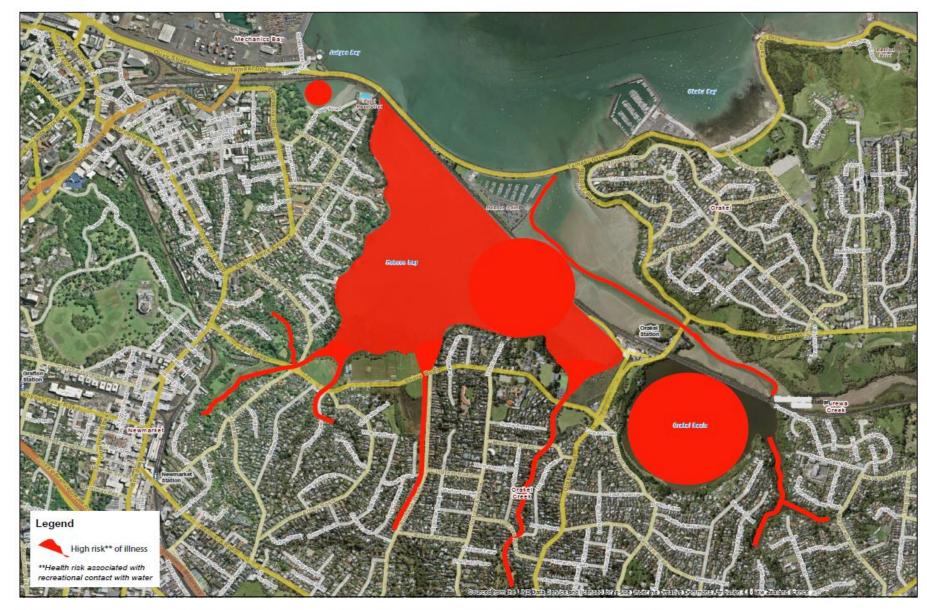
Newmarket/Hobson Bay wet weather sampling progress August 2020

This map represents data collected during 2019 and 2020. It represents the likely public health risk, with respect to NZ contact recreation guidelines, across Hobson Bay/Waitaramoa as at 19 August 2020 and is subject to change as investigations and corrective actions progress. This map has been prepared by Auckland Council Healthy Waters for the purpose of community engagement addressing this current public health risk. For further up to date information about where to swim, check <u>safeswim.org.nz</u>.

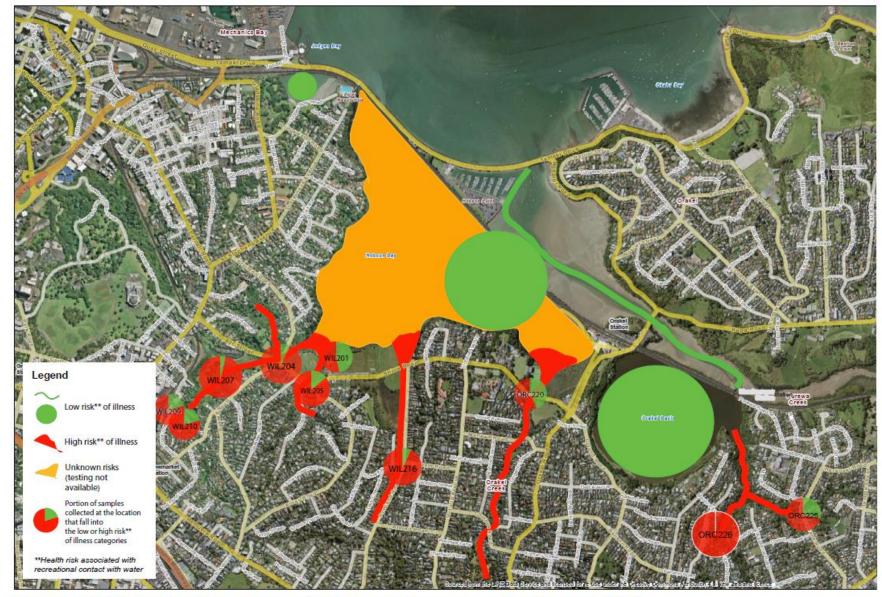
Newmarket/Hobson Bay dry weather* sampling progress August 2020

This map represents data collected during 2019 and 2020. It represents the likely public health risk, with respect to NZ contact recreation guidelines, across Hobson Bay/Waitaramoa as at 19 August 2020 and is subject to change as investigations and corrective actions progress. This map has been prepared by Auckland Council Healthy Waters for the purpose of community engagement addressing this current public health risk. For further up to date information about where to swim, check <u>safeswim.org.nz</u>.

*Less than 0.5mm of rain in last 48 hours
