# Hapua Thrive – Margot Nicholson

*Vision: 'a healthy valley and foreshore appreciated and nurtured by the community*

# Community concerns “STINK” Water Quality

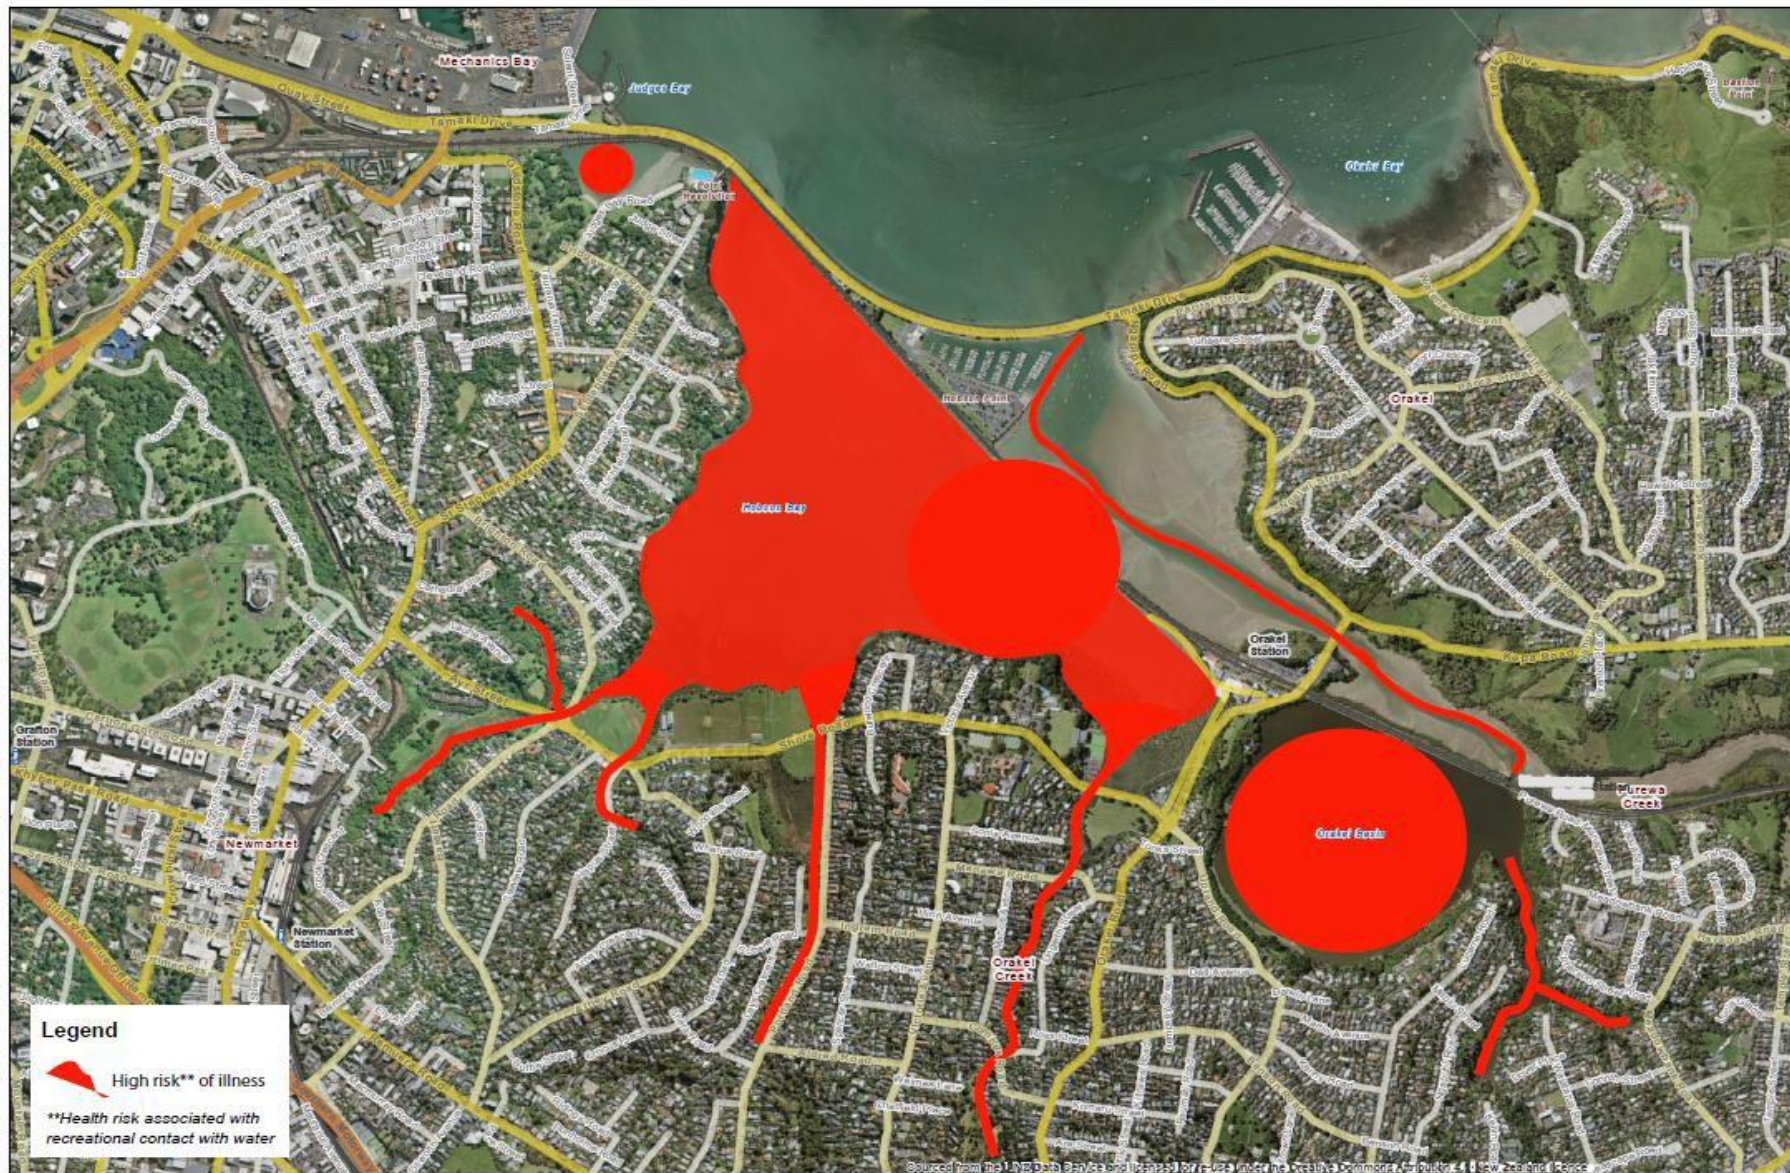
## Newmarket/Hobson Bay wet weather sampling progress August 2020

This map represents data collected during 2019 and 2020. It represents the likely public health risk, with respect to NZ contact recreation guidelines, across Hobson Bay/Waitaramoa as at 19 August 2020 and is subject to change as investigations and corrective actions progress. This map has been prepared by Auckland Council Healthy Waters for the purpose of community engagement addressing this current public health risk. For further up to date information about where to swim, check [safeswim.org.nz](http://safeswim.org.nz).

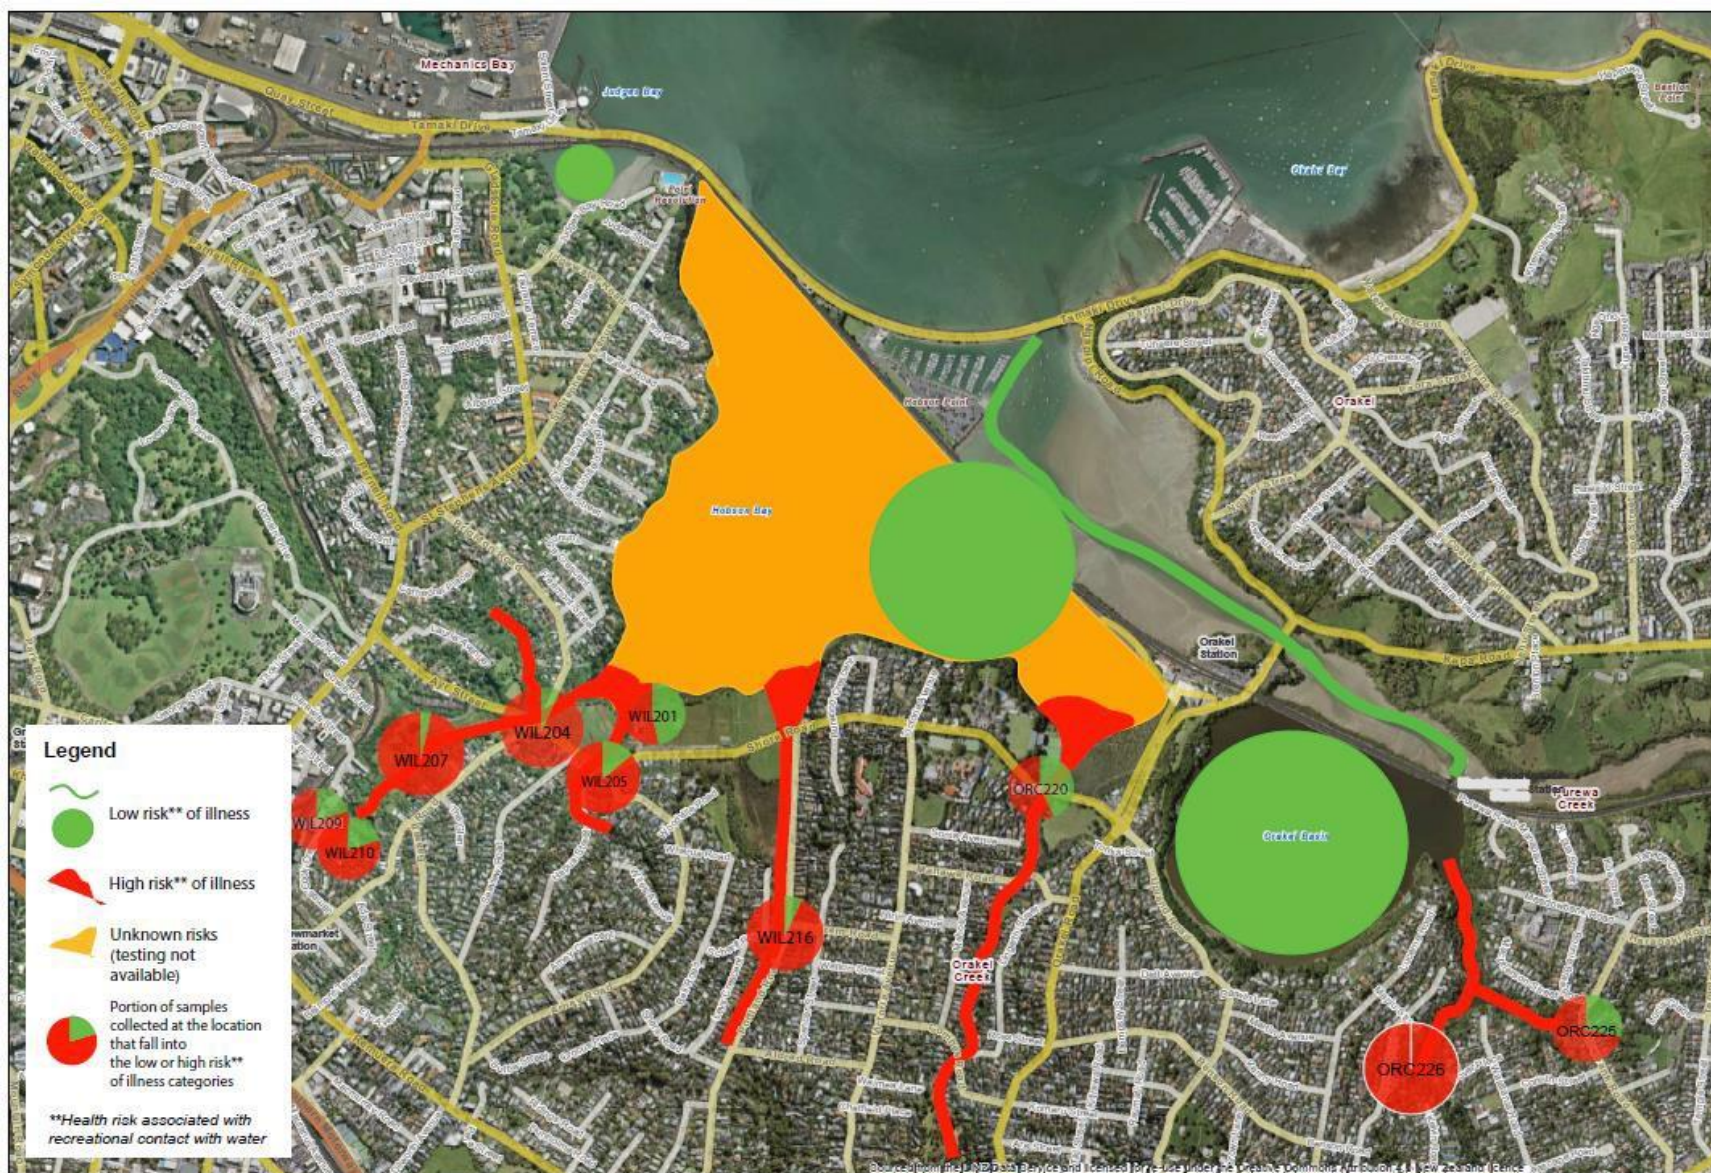
## Newmarket/Hobson Bay dry weather\* sampling progress August 2020

This map represents data collected during 2019 and 2020. It represents the likely public health risk, with respect to NZ contact recreation guidelines, across Hobson Bay/Waitararua as at 19 August 2020 and is subject to change as investigations and corrective actions progress. This map has been prepared by Auckland Council Healthy Waters for the purpose of community engagement addressing this current public health risk. For further up to date information about where to swim, check [safeswim.org.nz](https://safeswim.org.nz).

\*Less than 0.5mm of rain in last 48 hours
